NSFC, NSPC SERIES

STACKED FILM CHIP CAPACITORS

SUB: COMPONENT APPEARANCE

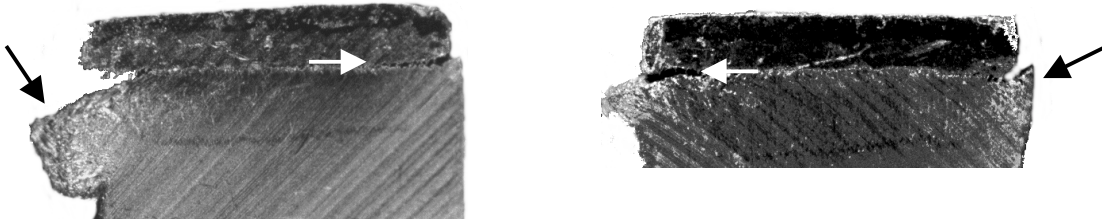
1. MAJOR DELAMINATION: >50% OF TOP – COVER LAYER OF PROTECTIVE FILM
2. MAJOR CURLING: >50% OF EDGES – CORNERS OF TOP – COVER LAYER OF PROTECTIVE FILM
3. IRREGULAR SURFACE: RISES – BUMPS – EVIDENCE OF MELTING IN THE TOP – COVER LAYER OF PROTECTIVE FILM
4. BULGING OF COMPONENT BODY: (SEE IMAGES BELOW)
5. SEPARATION OF END TERMINATION FROM BODY ELEMENT: (SEE IMAGES BELOW)
