NIC COMPONENTS CORP.

4/25/00

MECHANICAL FLEXURE CRACKING

PRODUCTS: SMT CERAMIC CHIP CAPACITORS ***SERIES: NMC, NMC-E & NMC-H***

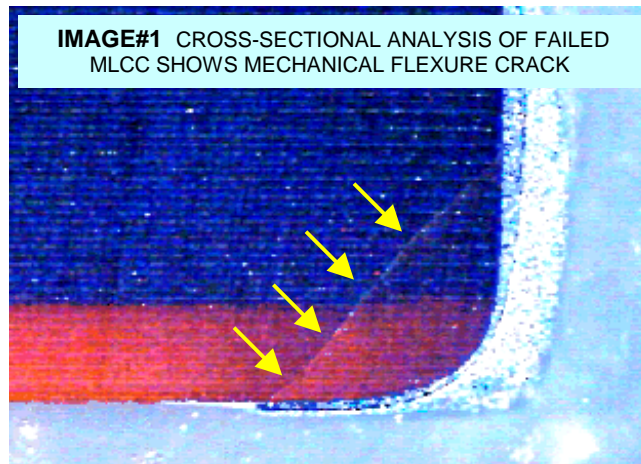
THE MOST COMMON CAUSE OF CERAMIC CHIP CAPACITOR FAILURE IS “SHORTED” – “LOW INSULATION RESISTANCE” – “HIGH LEAKAGE CURRENT” FAILURE MODE AS RESULT OF INTERNAL CONNECTION BETWEEN OPPOSING ELECTRODES.

CAUSE OF THIS CONNECTION IS MOST COMMONLY A MICRO-CRACK (SEE IMAGE #1).

CAUSE OF THE CRACKING IS VERY OFTEN THE RESULT OF MECHANICAL FLEXURE OF THE PCB AFTER COMPONENT SOLDERING. PCB FLEXURE DURING POST SOLDER OPERATIONS CAN RESULT IN MECHANICAL FLEXURE CRACKING IN CERAMIC BODY COMPONENTS (MLCC):
